De-Winterization Checklist

Mobile RV Tech Services

2020 Open Range 371 MBH

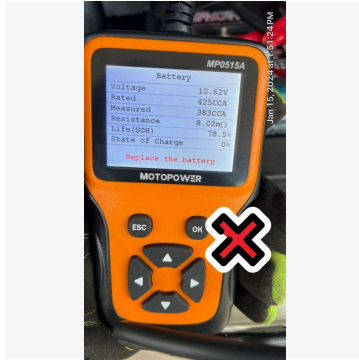
Battery test result failed with the battery voltage starting at 10.6 volts. The converter is charging the battery however the battery is not holding a charge when unplugged from shore power. A replacement battery is needed.

Group 24 Deep Cycle Battery

- Replace the battery.

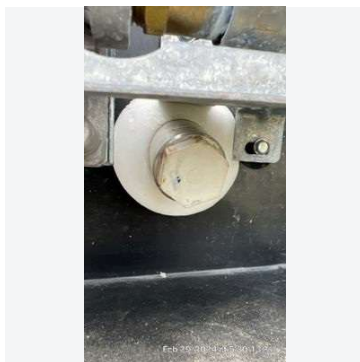
Existing water heater plug was in acceptable condition and re-used.

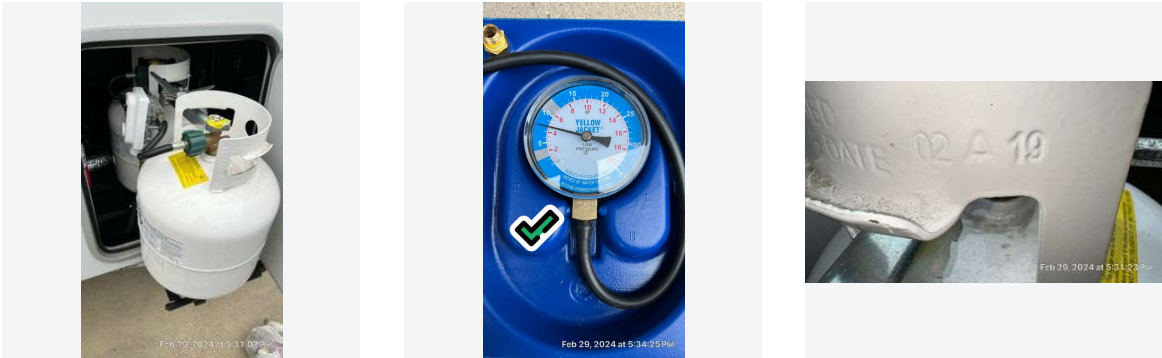
Propane pressure held at 8" for 3 minutes and the system does not have a detectable leak.

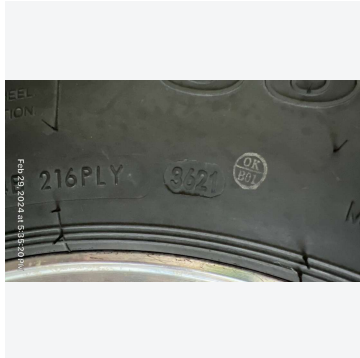
Tire date code 3621 (Sept. 2021)

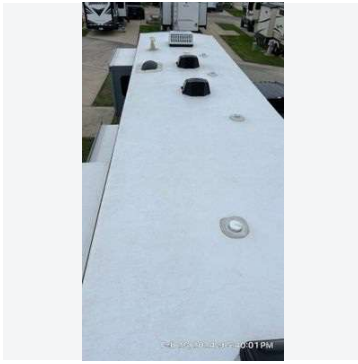
Sealant was previously repaired and in good condition.

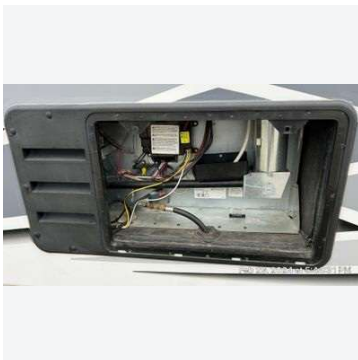
One old wasp nest was removed for the fridge vent area.

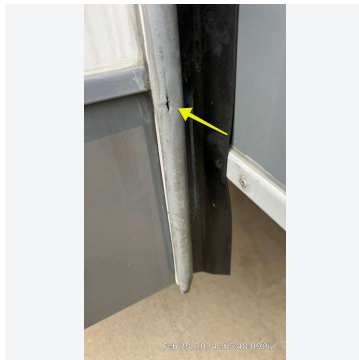
Slideout bulb seal on the right rear slide out, has a small tear 12" from the bottom. It is low enough that the tear is not a water intrusion point.
